# EDIMAX COMPUTER COMPANY

## EN-7008 (Version 1.0)

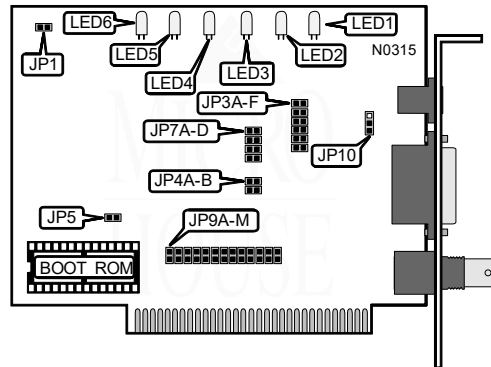
| <b>NIC Type</b> | Ethernet |
| <b>Transfer Rate</b> | 10Mbps |
| <b>Data Bus</b> | 8-bit ISA |
| <b>Wiring Type</b> | RG-58A/U 50ohm coaxial |
| | Unshielded twisted pair |
| | AUI transceiver via DB-15 port |

| CONNECTORS | |
|---|---|
| Setting | Jumper |
| External power LED | JP1 |

| CABLE TYPE | | | |
|---|---|---|---|
| Type | JP3A-JP3F | JP4A & JP4B | JP10 |
| iRG-58A/U 50ohm coaxial | Open | Closed | Pins 2 & 3 closed |
| Unshielded twisted pair | Closed | Open | Pins 2 & 3 closed |
| AUI transceiver via DB-15 port | Open | Open | Pins 1 & 2 closed |

| BOOT ROM ADDRESS | | | | |
|---|---|---|---|---|
| Address | JP7A | JP7B | JP7C | JP7D |

| BOOT ROM | |
|---|---|
| Setting | JP5 |

| I/O BASE ADDRESS | | | |
|---|---|---|---|
| Address | JP9A | JP9B | JP9C |

| INTERRUPT SETTINGS | | | | | | |
|---|---|---|---|---|---|---|
| IRQ | JP7D | JP7E | JP7F | JP7G | JP7H | JP7I |

| DIAGNOSTIC LED(S) | | | |
|---|---|---|---|
| LED | Color | Status | Condition |
